[Docket No. 91-ANE-29; Amendment 39-9470; AD 91-21-01 R1]

Airworthiness Directives; Textron Lycoming Model TIO-540-S1AD Reciprocating Engines

91-21-01 R1 Textron Lycoming : Amendment 39-9470. Docket 91-ANE-29. Revises AD 91-21-01, Amendment 39-8048, which superseded AD 89-12-04, Amendment 39-6214.

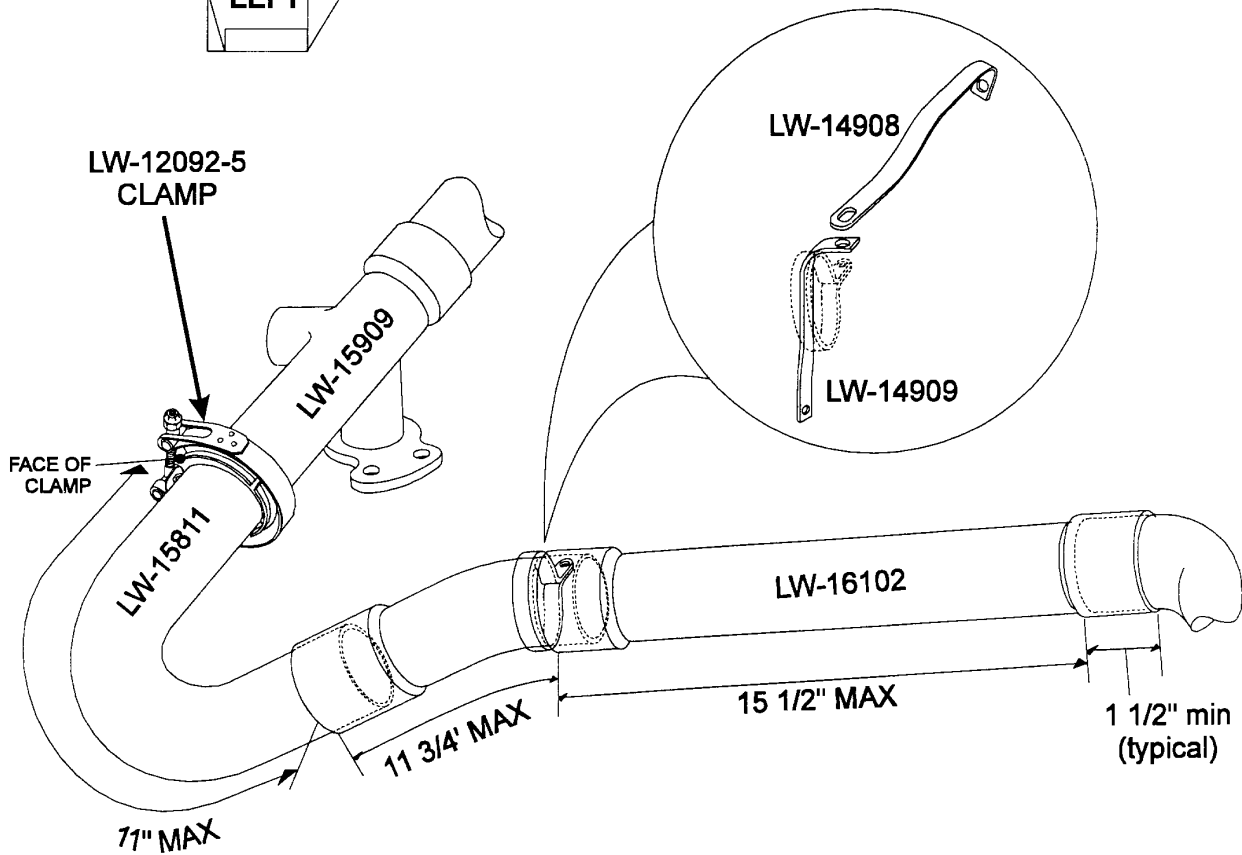
APPENDIX I
91-21-01 R1

(ii) Inspect the exhaust system for proper slip joint engagement by measuring distances between pipe end points in accordance with Appendix 1 of this AD.

(ii) Thereafter, at intervals not to exceed 100 TIS, perform exhaust system inspections specified in paragraph (a)(2)(i) and (a)(2)(ii) of this AD. Operators need to determine the minimum engagement of only exhaust pipes LW-16102 and LW-16103 by referring to Appendix 1 of this AD.

(iii) If damage is observed in the exhaust system or measurements exceed allowable dimensions, repair or replace parts with serviceable parts, as necessary prior, to further flight.

(iv) Reassemble and align exhaust system in accordance with Textron Lycoming SB No. 484, dated January 30, 1989, and Appendix 1 of this AD.
